LATEST NATURAL DISASTERS -NEW CHALLENGES FOR ENGINEERING GEOLOGY, GEOTECHNICS AND CIVIL PROTECTION

September 5-8, 2005 Sofia, Bulgaria

Loess Collapsibility Problem in Bulgaria

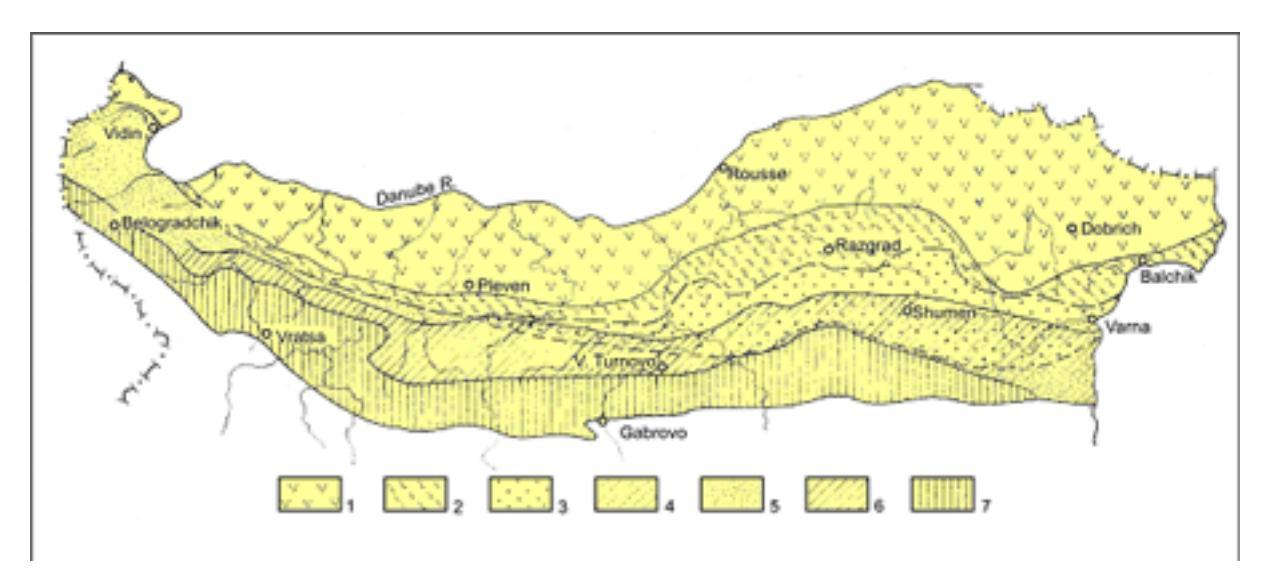
Fig. 1. Specific regions of the loess cover in North Bulgaria (by Minkov, 1968):

1-region with continuous cover (except on the flooded terraces and steep right side river banks); 2-region with episodically discontinuous cover; 3-region with discrete cover with Aeolian loess; 4-region with discrete cover with diluvial loess; 5-region with eluvial and diluvial clays; 6-transitional zone of the Fore-Balkan; 7-region of the Fore-Balkan with sporadic cover of diluvial loess-like deposits

The loess and loess-like sediments occupy 13 % of the territory of Bulgaria, i.e. about 14 000 km². The greatest part of them is distributed in the Danubian plain - about 12 000 km² (fig. 1). Here the loess is mainly of aeolian origin, the transfer of the silty material being from North and Northeast. There is a wide strip of loess-like clays situated to the South of the Danubian plain, which originate from weathered Lower Cretaceous marls. Loess-like sediments of alluvial origin are encountered in the big river terraces in South Bulgaria and along Black Sea sand dunes.

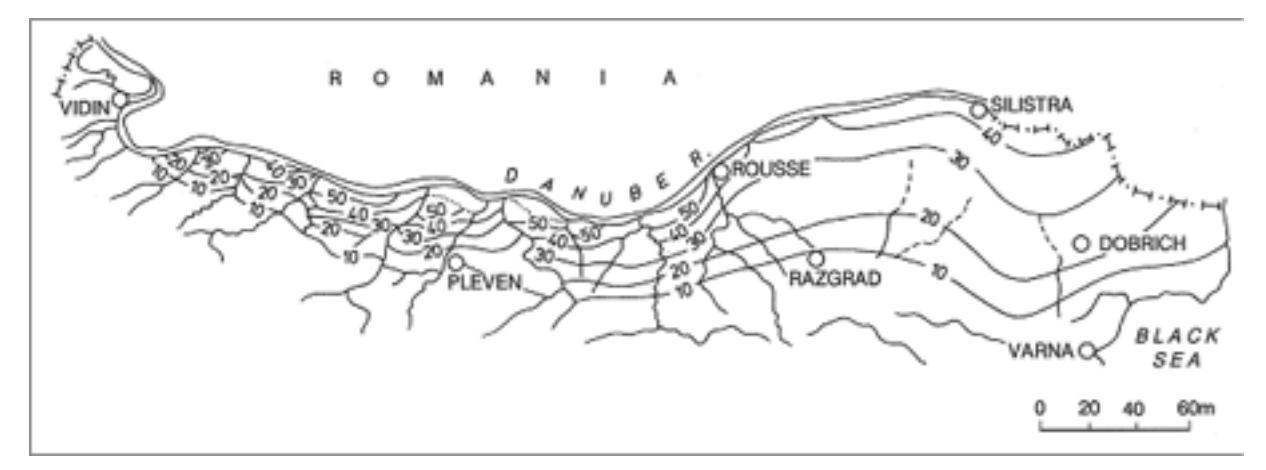
Fig. 2. Thickness of the loess in North Bulgaria (by Minkov, 1968)

The greatest loess thickness is along the Danube and varies from 40-50 up to 100 m. The thickness decreases in southern direction to several meters (fig. 2). It has been established by means of paleomagnetic methods that the beginning of loess accumulation in North Bulgaria dates back to the 0.82 Ma BP [4]. The geomorphologic conditions and climate changes during the Pleistocene exerted a substantial effect on the loess stratigraphy.

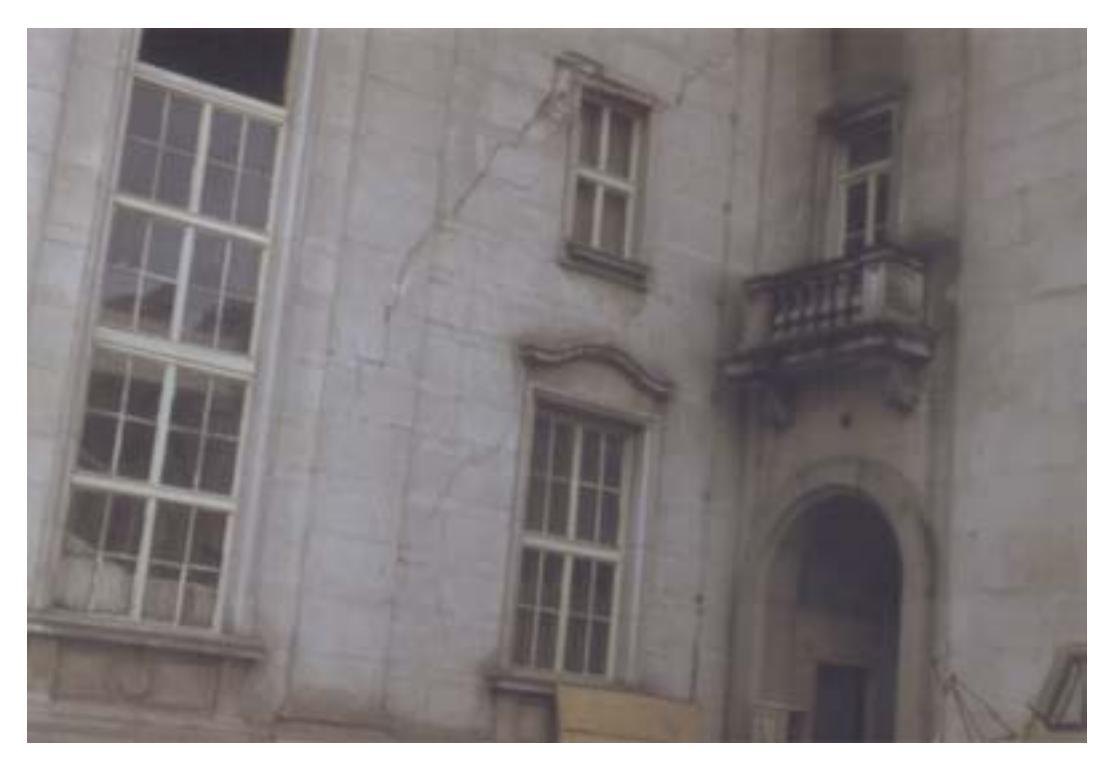
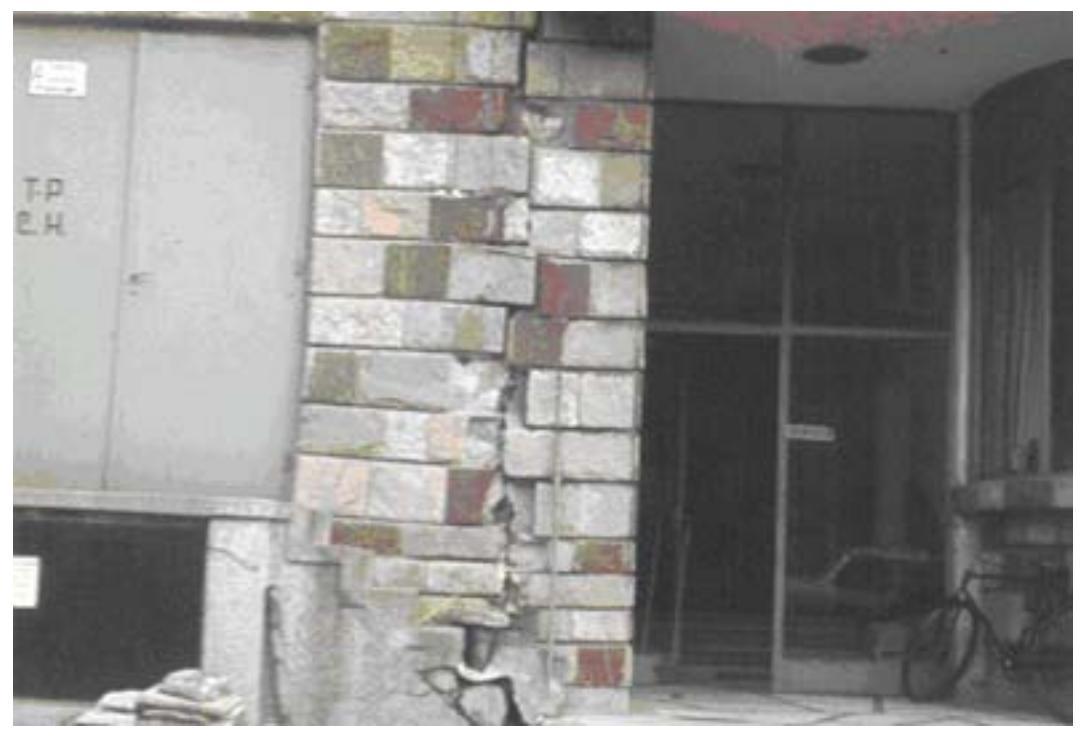
Fig. 3. Fissures on the construction walls: a. Rousse town railway station building, b. administrative building in Rousse town

Silty loess shows the greatest collapsibility under overburden pressure and in irrigation canals without lining collapsibility reaches 170 cm. A large number of buildings and equipment in Bulgaria were damaged by this phenomenon (fig. 3).
